# **QUAKER RUN Stream and Wetland Restoration**

## **As-Built Completion Report and First Year Monitoring Data**

### **Coal Township NORTHUMBERLAND COUNTY, PA**

**US FISH & WILDLIFE SERVICE  
PENNSYLVANIA FIELD OFFICE  
STATE COLLEGE, PA 16801  
14 December 2007**

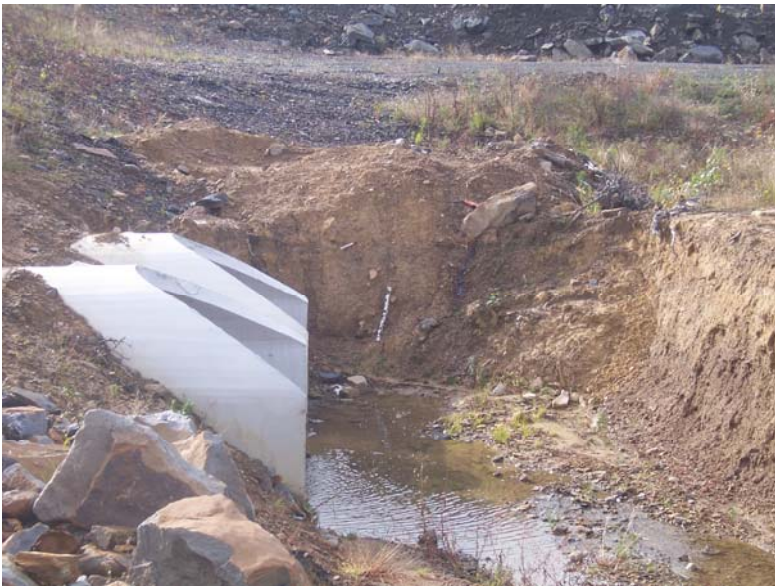
Figures 1 through 6 display before and after shots of different vantage points of the site. Figures 1 and 2 depict the first item that was addressed: the outlet to the two 5-ft concrete culverts in the middle of the site. The existing site had a severe scour hole that had developed and threatened the Kulpmont/Marion Heights Joint Sewer Authority (KMHJSA) sewer line at that location. The culverts could not be moved or replaced, and therefore they served as significant constraints to the restoration designs. The solution was a classic rip rap, energy dissipation pool. The outlet to this pool was set to an elevation slightly higher than that of the pipe inverts at their outlets. This was to back up water into the pipes at low flows in order to preserve some connectivity for aquatic wildlife at low flows. When the pipes flow at the median Quaker Run flows and higher, there is no backwater effect due to the energy dissipator, and therefore water and sediment can easily pass through the entire lengths of the culverts.

Figure 1. Energy Dissipator 30 November 2005.

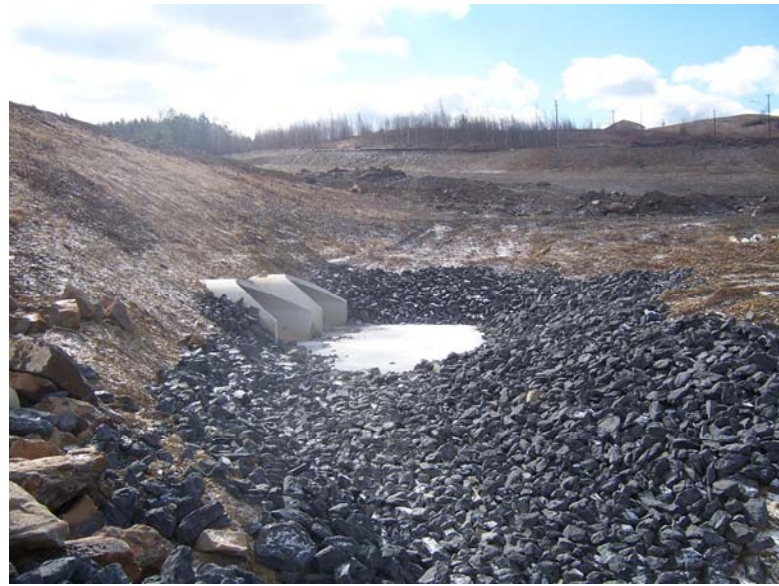
Figure 2. Energy Dissipator 28 February 2006.

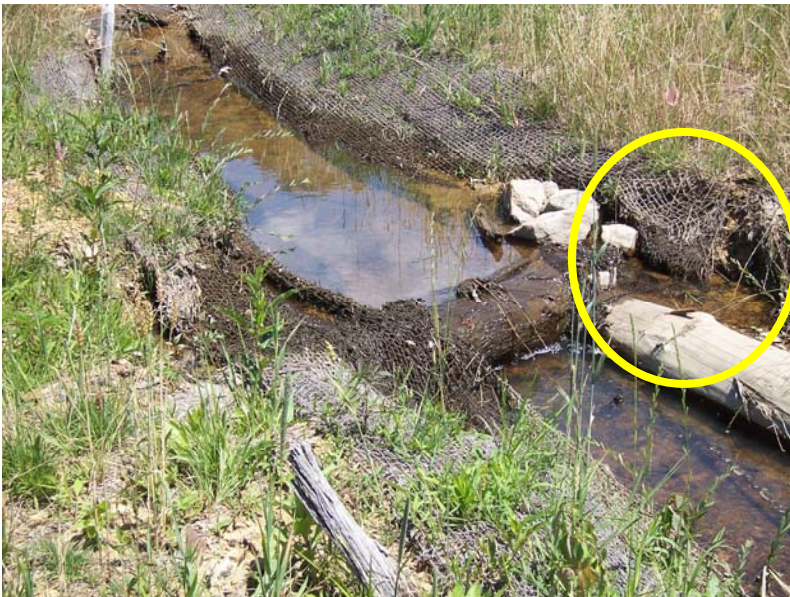
Figures 3 and 4 depict the upstream section, where in addition to reconstructing a geomorphically-designed stream, new wetlands were also created. Figures 5 and 6 depict the downstream section. New wetlands, created by this project, were so successful; the Shamokin Creek Watershed Association took some tadpoles from these wetlands for introduction to other sites (Leanne Bjorklund, personal communication). Some instabilities (erosion) were detected close to the structures on the steep channel section in the upper part (Figure 7). The lower, steep section is basically a rip rap channel (Figure 8), and appears very stable.

Figure 7. Erosion at Vane 30 June 2007 (yellow circle).

Some maintenance was performed in July, 2007. Two principle locations that required attention were the steeper upstream section (B-channel) and the middle third of the lower section. The steep upstream channel section required additional bed and bank armoring near to structures. The middle third of the downstream section exhibited water loss, and was therefore overexcavated and refilled with onsite clay material taken from the floodplain.

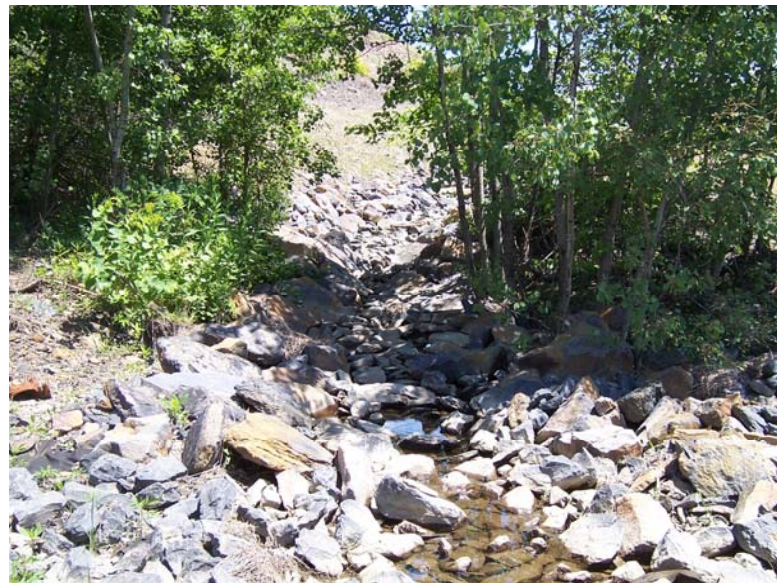
Figure 8. Steep B-channel at lower end 30 June 2007.

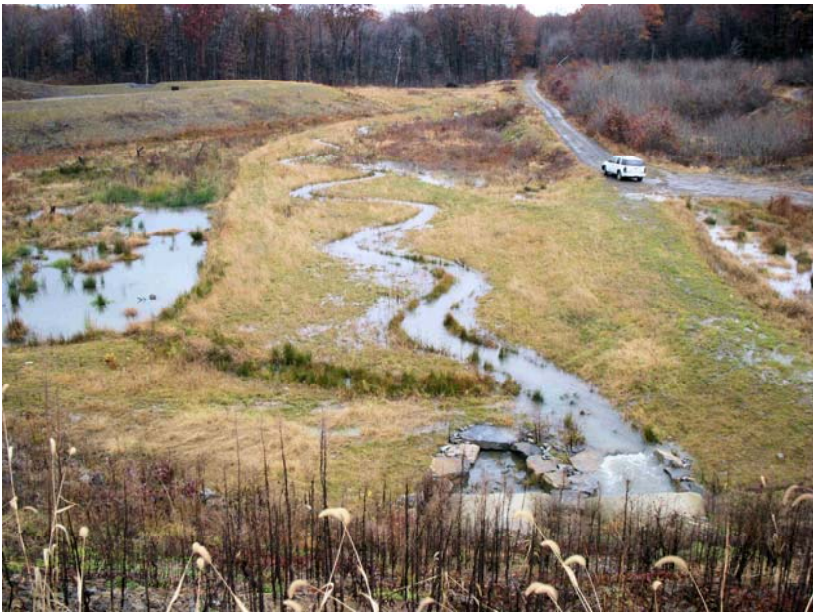
On November 16, 2007, 1.5 inches of rain fell in the general area. This precipitation created a bankfull event (Figures 9 and 10). The stream performed remarkably well: velocities were acceptable; structures performed well; and the stream used its floodplain.

Figure 9. Bankfull event, upstream section 16 November 2007.

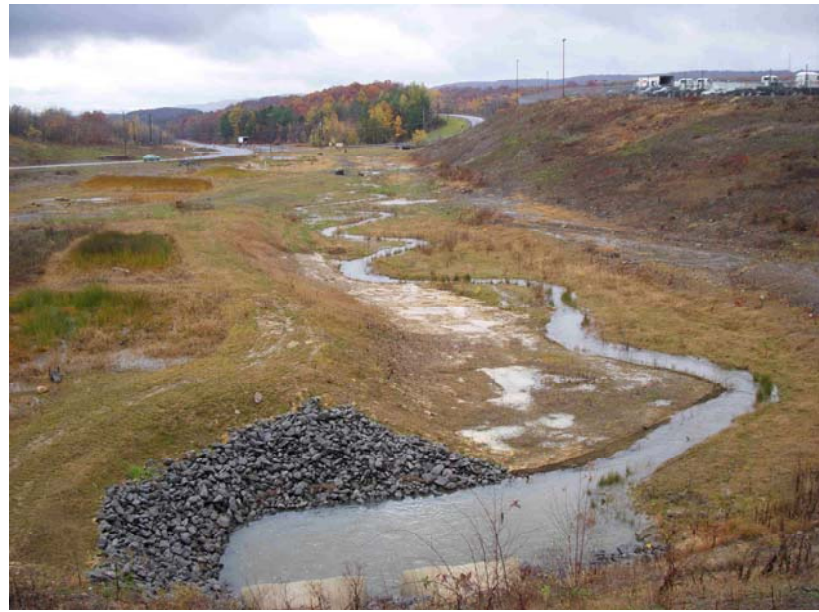
Figure 10. Bankfull event, downstream section 16 November 2007.

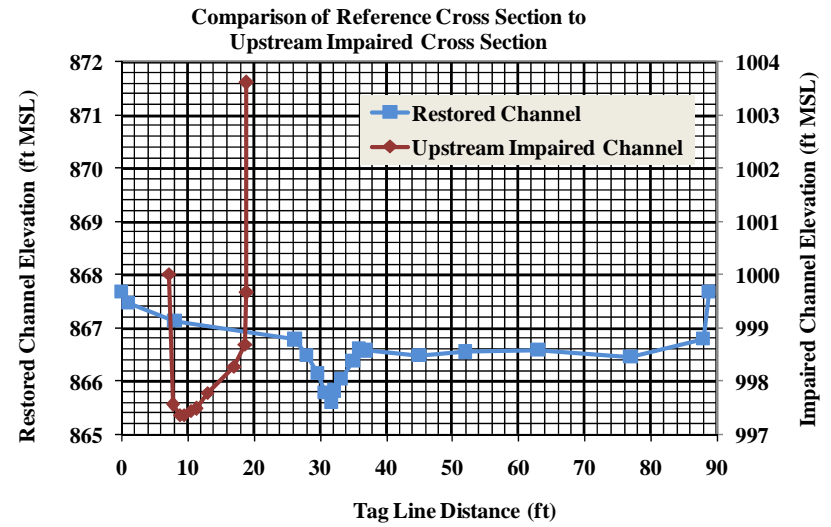
It is interesting to point-out that Quaker Run upstream of the restored reach is impaired (that is why it could not serve as a reference reach). Although it is in a forest setting, the banks and bed are unstable and have demonstrated these instabilities with the erosion pins that were installed in 2006. Bank pins exhibit 0.2 to 2 feet of lateral erosion, and bed pins 0.0 to 0.3 ft of bed erosion. One cross section Station 2+47, Figure 16) suffered a large slump failure of bank material. A comparison of a typical riffle cross section in the restored and upstream impaired Quaker Run appears in Figure 14. In this Figure, the impairment characteristics of entrenchment and steep banks are apparent (Figures 15 and 16). The impaired channel is widening (eroding its banks) to create a suitable floodplain. This upstream reach of Quaker Run should be targeted as a future restoration project.

Figure 14. Comparison of restored and impaired cross sections.

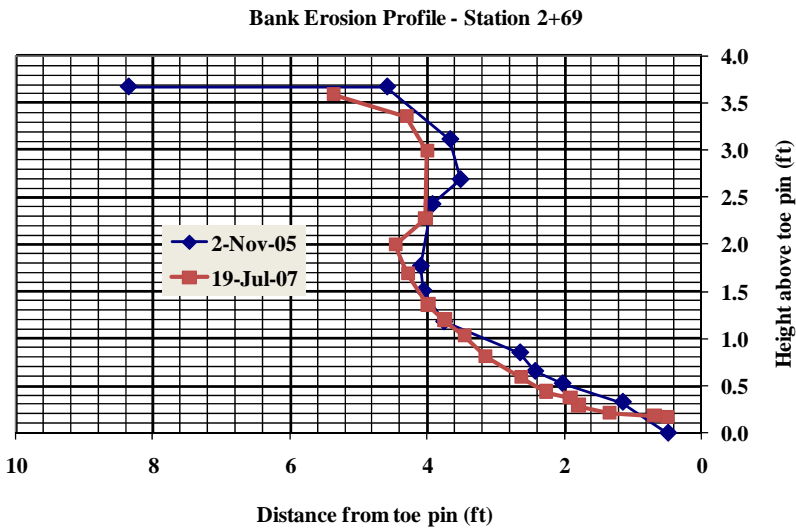
Figure 15. Bank erosion at upstream station 2+69.

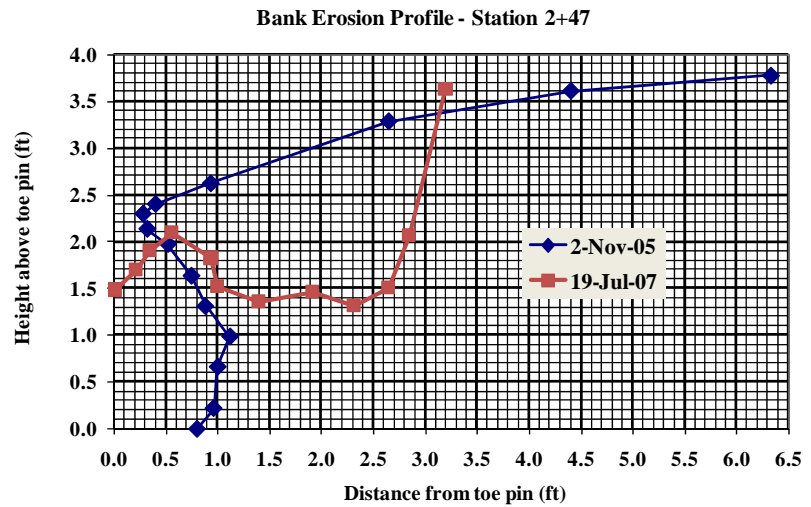
Figure 16. Bank erosion at upstream station 2+27.
