# **QUAKER RUN Stream and Wetland Restoration**

## **As-Built Completion Report and First Year Monitoring Data**

### **Coal Township NORTHUMBERLAND COUNTY, PA**

**US FISH & WILDLIFE SERVICE  
PENNSYLVANIA FIELD OFFICE  
STATE COLLEGE, PA 16801  
14 December 2007**

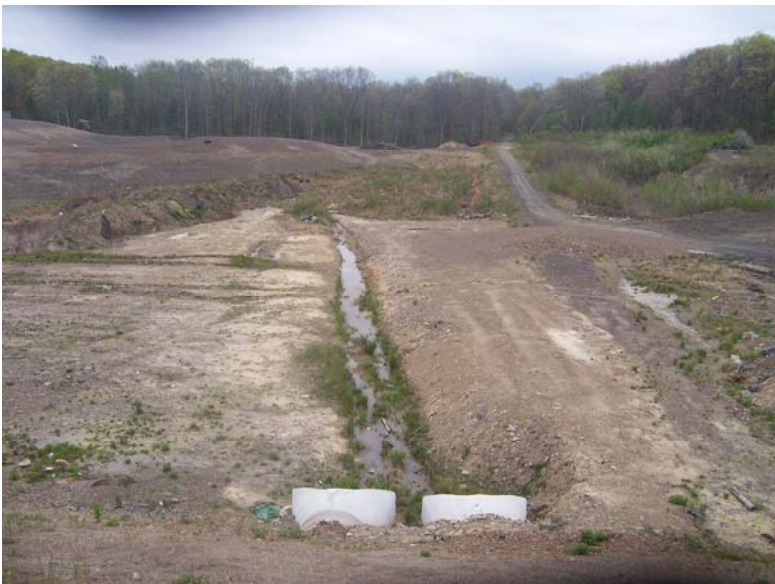
Figure 3. Existing Upstream Section 11 May 2006.

Figures 3 and 4 depict the upstream section, where in addition to reconstructing a geomorphically-designed stream, new wetlands were also created. Figures 5 and 6 depict the downstream section. New wetlands, created by this project, were so successful; the Shamokin Creek Watershed Association took some tadpoles from these wetlands for introduction to other sites (Leanne Bjorklund, personal communication). Some instabilities (erosion) were detected close to the structures on the steep channel section in the upper part (Figure 7). The lower, steep section is basically a rip rap channel (Figure 8), and appears very stable.

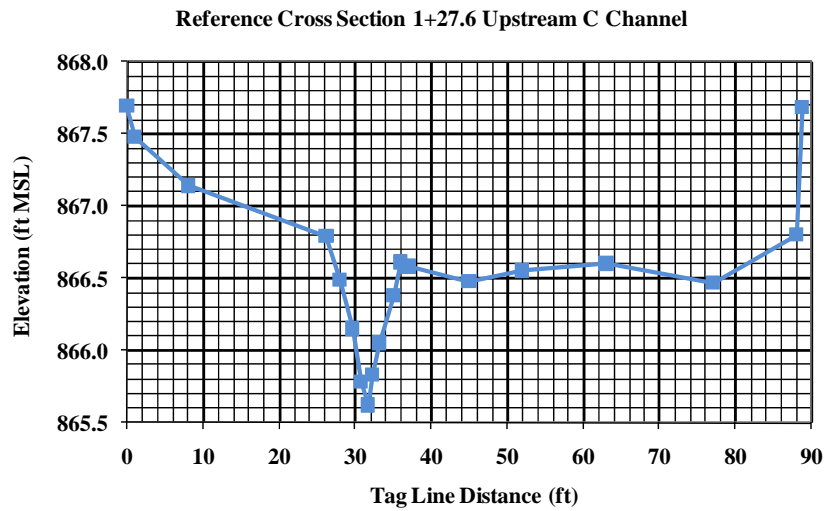
Figure 11. Reference Cross Section 1+27.6 Upstream.

Three reference cross sections were established for the restored Quaker Run. In addition, there are three reference cross sections on Quaker Run upstream of the restoration as well as four locations of bank erosion pins in the upstream Quaker Run. Two of the reference reach cross sections (Figures 11 and 12) in the restored Quaker Run are on the upstream portion (one in the steep and one in the flatter reaches), and one reference cross section is on the downstream portion (Figure 13).

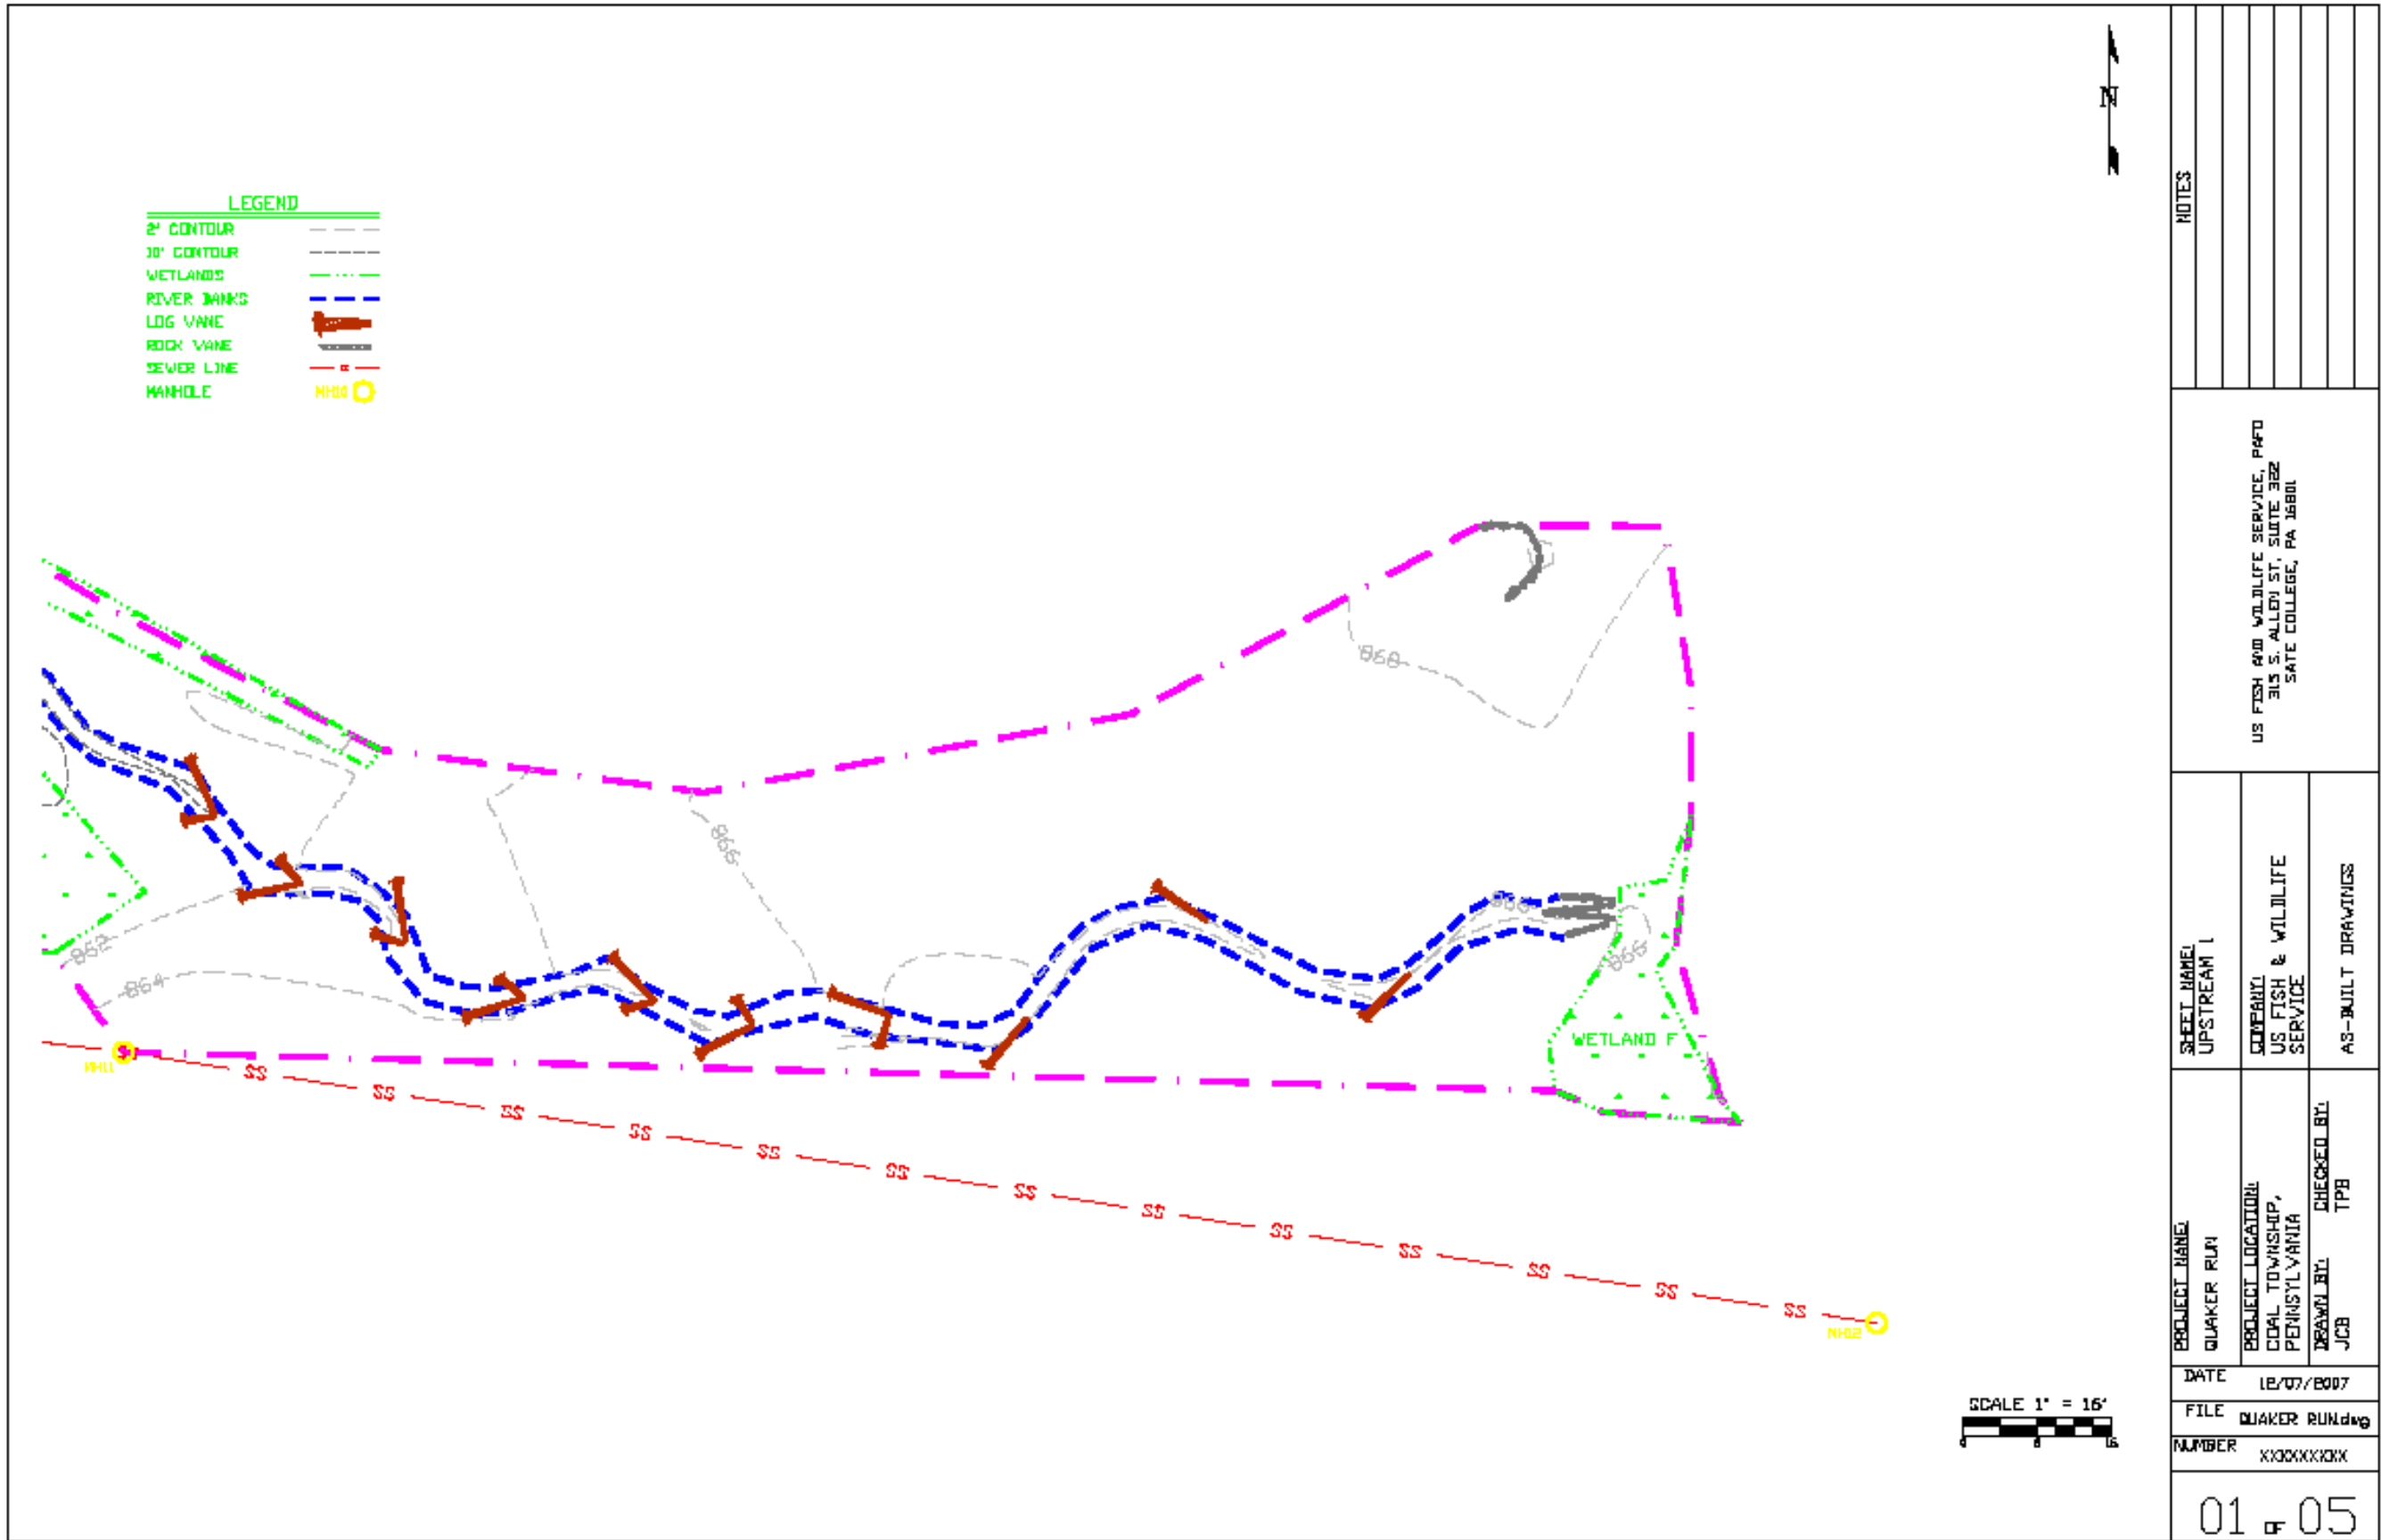
Figure 17. As-Built Upper Quaker Run Stream Alignment – part 1.

In July 2007, an as-built survey was conducted. The as-built plans may be found in Figures 17 through 21.
